OCCURRENCE OF IRON OXIDES ON CAST-IRON ENGINE

SURFACES AFTER OPERATION

By A. S. Nowick and L. O. Brockway

Aircraft Engine Research Laboratory
Cleveland, Ohio

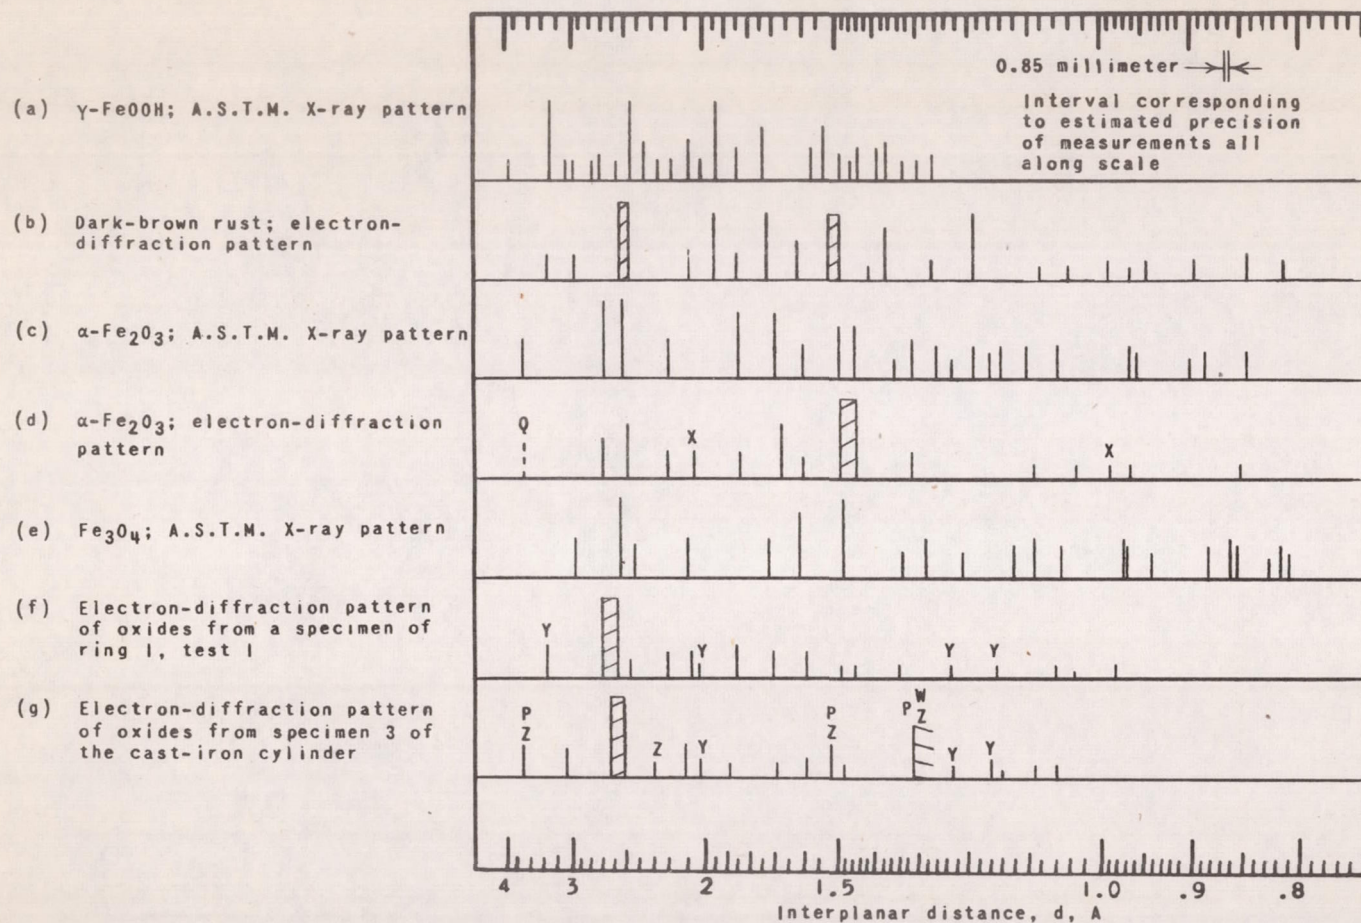
Figure 1. - Comparison of iron-oxide patterns. The notation within the scale is as follows:

- P These lines show preferred orientation.
- Q This α -Fe₂O₃ line does not appear in the pattern because of halation of the image of the central beam.
- W The intensity decrease at the outer edge of this ring is gradual.
- X These lines are not from α -Fe₂O₃ and probably are the results of impurities.
- Y These lines are probably graphite lines.
- Z Unidentified lines.

Included in the data are the following comparison patterns: electron-diffraction patterns of α -Fe₂O₃ (fig. 1(d)); graphite and α -iron (figs. 2(d) and 2(e), 3(f) and 3(g), and 4(e) and 4(f), respectively); and A.S.T.M. X-ray diffraction patterns of γ -FeOOH, α -Fe₂O₃, and Fe₃O₄ (presented in figs. 1(a), 1(c), and 1(e), respectively). Photographs of the α -iron, graphite, and α -Fe₂O₃ patterns are presented in figures 5(a), 5(b), and 5(c), respectively. The presence of impurities is indicated by the presence of additional rings (marked X in the corresponding comparison plots): two rings in the α -Fe₂O₃ pattern (fig. 1) and one ring in the graphite pattern (fig. 2). These rings are probably a result of the method of preparation of the specimens. For example, the additional ring in the graphite electron-diffraction pattern is probably from an oxide of iron, formed by the slight oxidation of the iron by the nitral solution used to prepare the graphitic surface. The α -Fe₂O₃ ring at 3.68 Å may not always appear in the electron-diffraction photographs because it can be obscured by the shadow line if the specimen extends too far into the beam or by halation of the image of the central beam in long exposures.

The electron-diffraction pattern of the specimens from piston ring 1 of test 1 (see table 1) that gave the best oxide lines is presented in figures 1(f) and 6(a). Comparison with the reference patterns shows that this oxide is not γ -FeOOH but consists of α -Fe₂O₃ and Fe₃O₄. It should be noted that γ -Fe₂O₃ and Fe₃O₄ are both cubic crystals having the same cell edge and having unit-cell structures sufficiently alike to make them indistinguishable by diffraction methods. For convenience, further reference in this report to an identification as Fe₃O₄ will imply Fe₃O₄, γ -Fe₂O₃,

or both. In addition to the oxide rings, the four strongest graphite rings (marked Y in fig. 1(f)) appear, which shows the presence of a relatively small amount of graphite.

An oxide pattern from a specimen taken near the top of the cast-iron cylinder (specimen 3, table 2) is given in figure 1(g). This pattern also shows the presence of relatively little graphite and differs from the preceding pattern in the presence of three rings showing preferred orientation. Although the first of these rings coincides with the ring of $\alpha\text{-Fe}_2\text{O}_3$ at 3.68 A, the other two do not agree with rings of any known oxide of iron. The three rings probably belong to the same material because their arcs subtend the same angle, which is about one-sixth of the angle of all the other rings of the pattern. The other rings (except for that at 2.30 A, marked Z in fig. 1(g)) correspond to Fe_3O_4 with traces of graphite and possibly $\alpha\text{-Fe}_2\text{O}_3$.

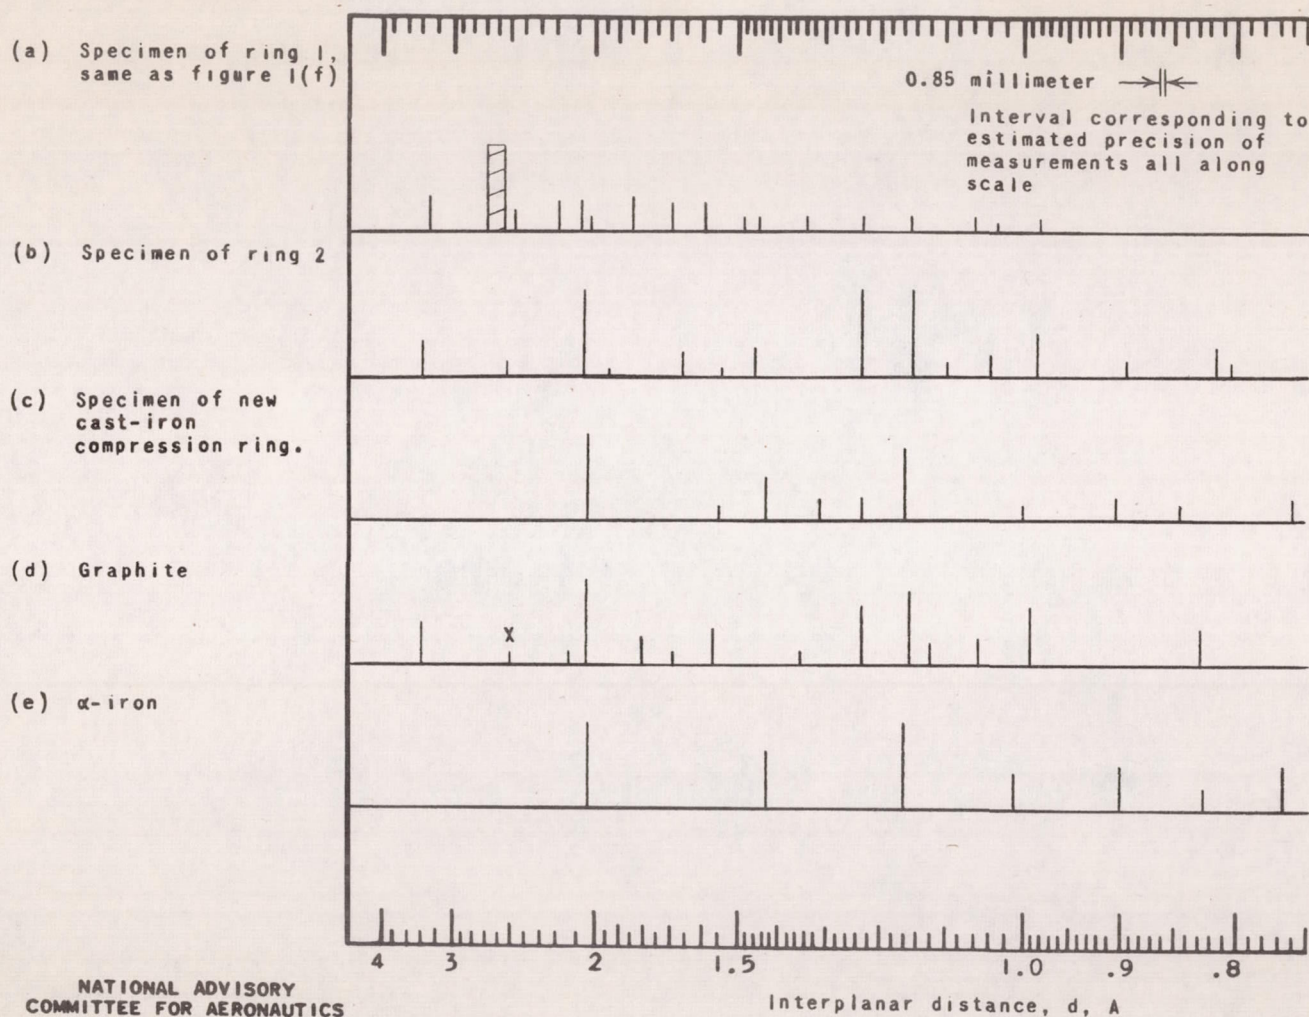
Figure 2. - Electron-diffraction patterns from piston rings run in a liquid-cooled single-cylinder engine (test 1, table 1) and electron diffraction comparison patterns. The notation is explained as follows:

X This line is not from graphite and probably is the result of oxide impurities.

Patterns from two cast-iron piston rings of test 1 (table 1) are compared in figure 2 with patterns from the new cast-iron top compression ring, graphite, and α -iron. Except for the line at 1.31 A, the pattern from the new ring (fig. 2(c)) is seen to correspond to α -iron and graphite, predominately α -iron. The pattern plotted in figure 2(a) (same as fig. 1(f)) is from a specimen of ring 1, test 1, and has previously been identified as $\alpha\text{-Fe}_2\text{O}_3$ and Fe_3O_4 . Three other specimens from different parts of the same piston ring showed the presence of oxides, although the specimen from which the pattern of figure 2(a) was obtained showed the greatest quantities of oxides, relative to graphite and α -iron. On the other hand, patterns from ring 2 of the same test (figs. 2(b) and 6(b) are representative) showed graphite with smaller amounts of α -iron and only faint traces of oxides; specimens from the third compression ring and the oil rings (test 1) showed graphite with relatively small amounts of α -iron but no oxide diffraction rings.

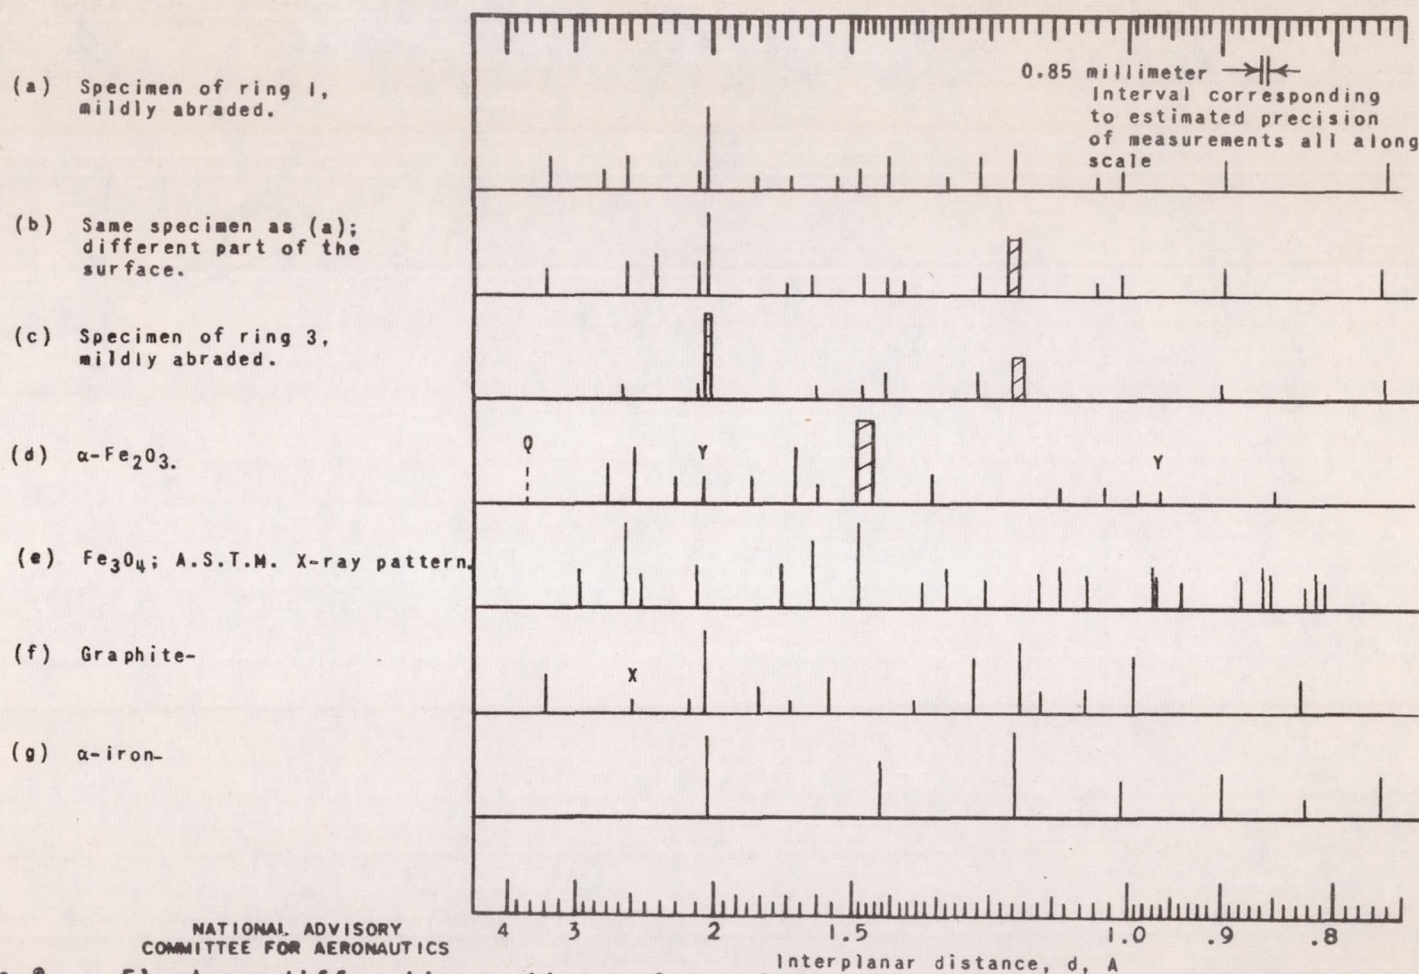
Figure 3. - Electron-diffraction patterns from piston rings run in an air-cooled single-cylinder engine (test 4, table 1) and electron-diffraction comparison patterns. The notation is explained as follows:

- Q This $\alpha\text{-Fe}_2\text{O}_3$ line does not appear in the pattern because of halation of the image of the central beam.
- X This line is not from graphite and probably is the result of oxide impurities.
- Y These lines are not from $\alpha\text{-Fe}_2\text{O}_3$ and probably result from impurities.

The results of this method applied to piston rings of test 4 are plotted in figure 3. Figures 3(a) and 3(b) show two patterns obtained from the same specimen of ring 1; each pattern has four extra rings (other than graphite and α -iron rings) of which two have the same d values in both patterns. The extra rings in the pattern of figure 3(a) were attributed to α -Fe₂O₃ because, together with two rings common to both graphite and α -Fe₂O₃, they account for six of the strong α -Fe₂O₃ rings. In the case of the pattern of figure 3(b) (photograph shown in fig. 6(d)), three of the four extra rings correspond to Fe₃O₄ (the fourth is unidentified), which indicates the presence of that substance. Examination of several specimens of each of the other compression rings from test 4 showed that the extra diffraction rings are weaker for the second piston ring and very faint for the third. For example, figure 3(c) shows one of the patterns obtained from the third piston ring using the same abrasion technique. The three extra rings agree with those appearing in figure 3(b) but are extremely faint. The oxide gradation, therefore, is similar on the rings of test 4 to that observed on the rings from the other three tests.

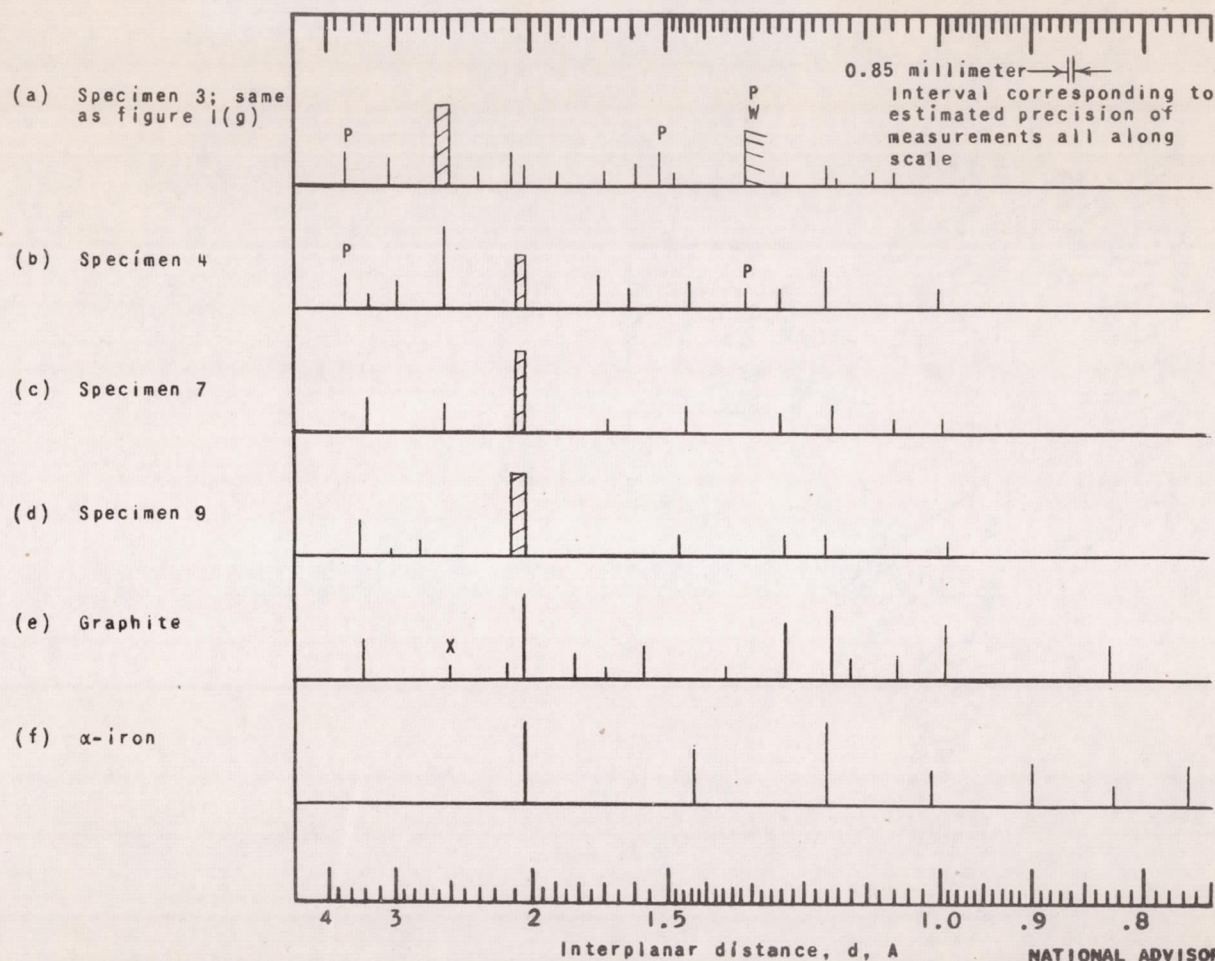
Figure 4. - Electron-diffraction patterns from specimens of a cast-iron cylinder operated for a long period of time (table 2) and from graphite and α -iron. The notation is explained as follows:

- P These lines show preferred orientation.
- W The intensity decrease at the outer edge of this ring is gradual.
- X This line is not from graphite and probably is the result of oxide impurities.

The specimens from the cast-iron cylinder examined and the identification of patterns obtained from them are listed in table 2. In the previous discussion of identification of the oxides, it was noted that the pattern from specimen 3 indicated the presence of Fe_3O_4 and possible traces of $\alpha\text{-Fe}_2\text{O}_3$. Specimen 1 from the region of the cylinder above the piston-ring stroke was covered by oil combustion products most of which were removed by washing with several organic solvents before diffraction photographs were taken. Some "lacquer" remaining on the surface probably accounts for the high background and failure of sharp rings to appear until after abrasion, when a strong pattern of Fe_3O_4 appeared. Two specimens, 8 and 9, from the region of the cylinder below ring travel failed to show the presence of iron oxides in detectable quantities.

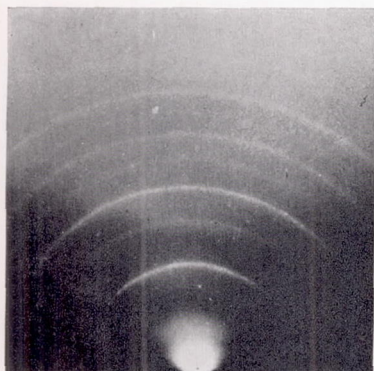
(a) α -iron.

The comparison electron-diffraction patterns used for the identification of unknown patterns were those of α -iron, graphite, α -Fe₂O₃, and γ -FeOOH. The α -iron pattern was obtained from a sample of cold-rolled steel of very low carbon content mildly abraded with emery paper. The graphite pattern was obtained by etching cast iron with a 2-percent nital solution (2-percent nitric acid in methyl alcohol) for 30 seconds. A specimen of the low carbon steel, abraded, etched with dilute aqueous nitric acid for about 30 seconds, and finally heated until blue interference colors appeared, gave a pattern principally of α -Fe₂O₃. A pattern principally of γ -FeOOH was obtained from rust specimens prepared from cast-iron placed above water at 50° C for 24 hours. It is desirable to make comparison with diffraction patterns from known materials obtained by electron diffraction rather than by X-ray diffraction wherever possible because the relative intensities in electron patterns may differ greatly from the X-ray intensities as a result of the large absorption factor of the specimens for electrons. The X-ray patterns available in the A.S.T.M. card file are useful in checking the positions of the diffraction rings.

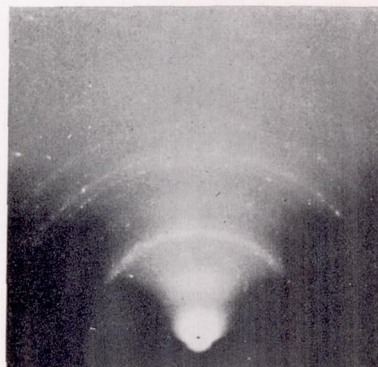
(b) Graphite (from cast iron etched with 2 percent nital).

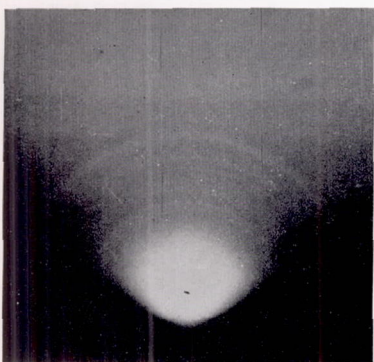
(c) α -Fe₂O₃ (from a steel specimen etched, then heated).

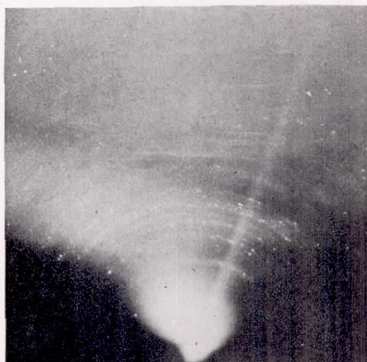
(d) γ -FeOOH with small amounts of Fe₃O₄ (from rusted cast iron).

A further comparison was made with the oxide formed by rusting in humid air. Electron-diffraction patterns from various rusted specimens were found to be very similar except for the appearance in the diffraction patterns of dark brown rust of three strong diffraction rings that do not appear in the patterns of the lighter, orange rust. These three diffraction rings, which are at 2.55 Å, 1.62 Å, and 1.49 Å, are the three strongest rings of Fe₃O₄. Figures 1(b) and 5(d) show the pattern from dark brown rust. A comparison of this pattern with figure 1(a), the X-ray diffraction pattern of γ -FeOOH, shows that rust is predominately γ -FeOOH with some Fe₃O₄ present in the case of this dark brown rust. This identification is in agreement with other sources. (See reference 4.)

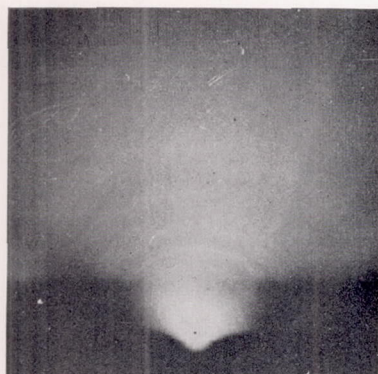
(a) Pattern from cast-iron ring 1, test 1, identified as α - Fe_2O_3 and Fe_3O_4 .

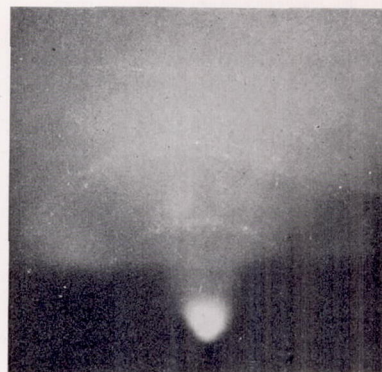
(b) Graphite pattern from cast-iron ring 2, test 1.

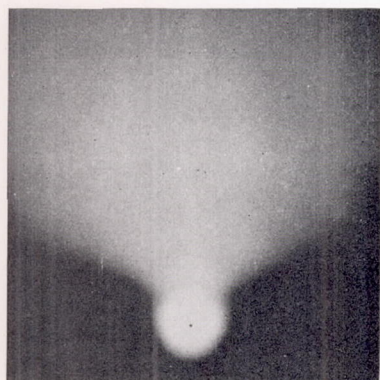
(c) Diffuse pattern from ring 1, test 4.

Used rings from test 4 were examined but gave diffuse patterns (fig. 6(c)) and a high background because of the highly polished surfaces of these rings. In order to obtain information on the oxides present, the rings were very mildly abraded using different grades of emery paper. The method consisted in making two to four strokes in the same direction along the specimen, using a minimum of pressure. The specimen was then placed in the diffraction chamber without washing off the debris. This "plowing" operation so raised the surface material that sharp diffraction rings could be obtained. Some iron located below the surface was torn up in the process and contributed to the diffraction pattern. From each ring examined by this abrasion method, two or three specimens were taken and several exposures made for each, first without any surface disturbance and then with increasing amounts of abrasion.

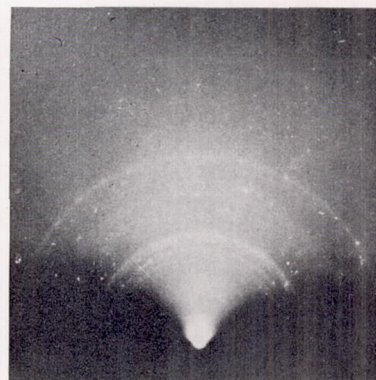
(d) Pattern from same specimen as 6(c) (after mild abrasion) showing oxide rings in addition to α -iron and graphite.
